## Technical Review of Tree Related Issues in ACE Paper 8/2023

(Rev.2)

This Paper summarizes the findings of a Technical Review of Sections 5, 6 and 8 of ACE Paper 8/2023: Reporting of the Additional Information prepared for the EIA Report on “Technical Study on Partial Development of Fanling Golf Course – Feasibility Study”. Reference is also made where appropriate to the original Environmental Impact Assessment (EIA) Report that was uploaded for public viewing in June 2022.

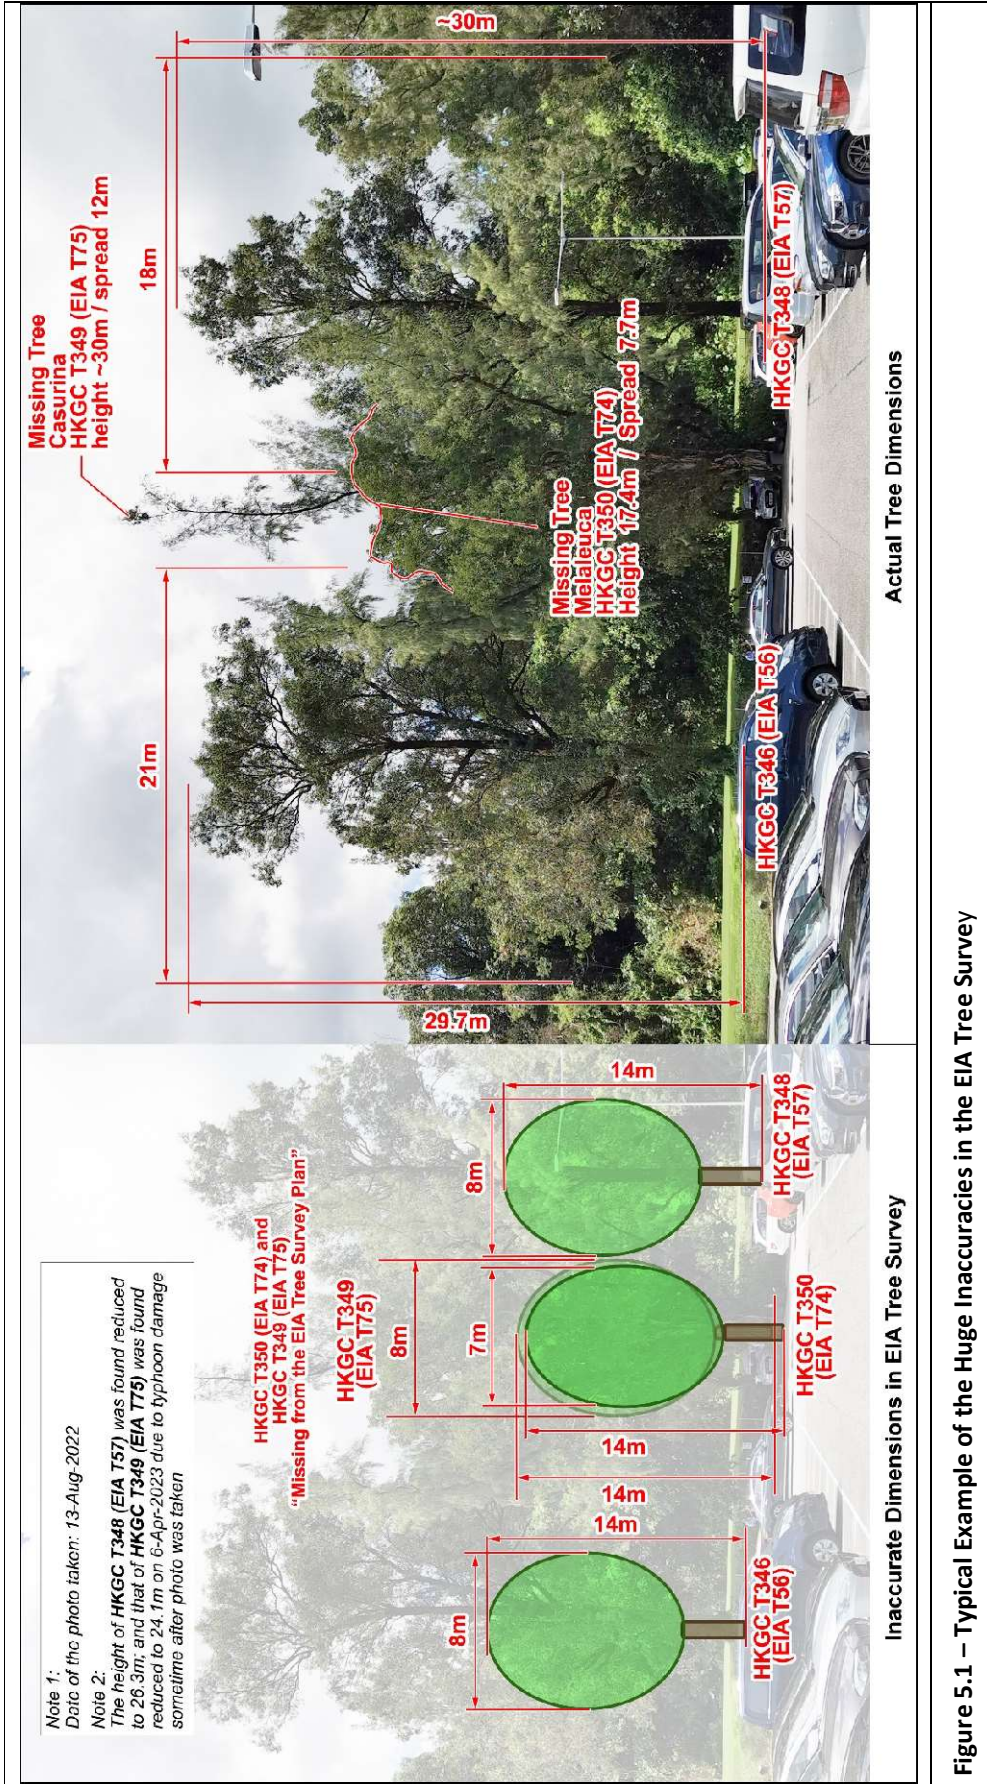
Figure 5.1 – Typical Example of the Huge Inaccuracies in the EIA Tree Survey

The entire Section 5 is seriously flawed and invalid because it is based in a grossly inaccurate and incompetent Tree Survey which has failed to record 460 trees located on site and which records grossly inaccurate (far too small) tree dimensions (DBH, height, canopy spread), wrongly mapped trees locations and incorrect species identification. **Figure 5.1** illustrates typical examples of the huge inaccuracies in the EIA Tree Survey.

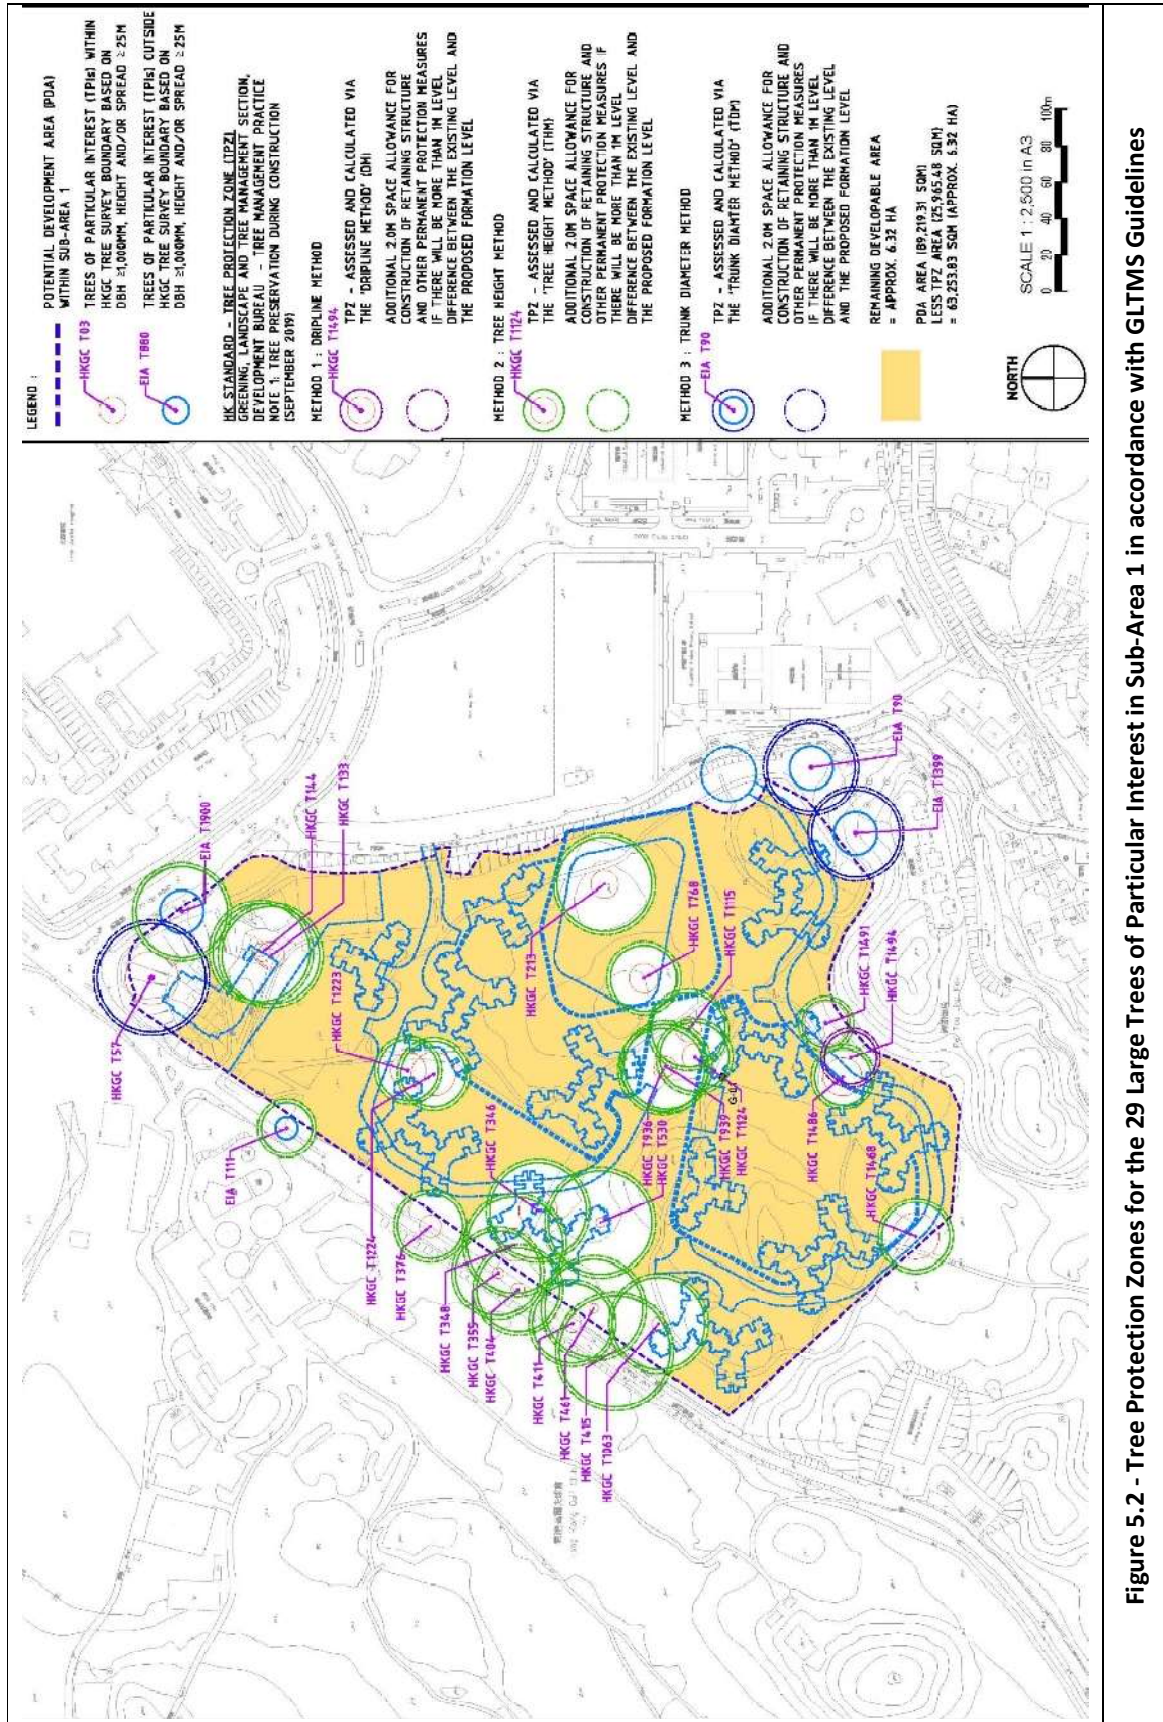
Figure 5.2 - Tree Protection Zones for the 29 Large Trees of Particular Interest in Sub-Area 1 in accordance with GLTMS Guidelines

**Numbers of OVTs in Existing PHDs.** The claim in paragraph 5.4.3 that there are “*abundant cases of OVTs being maintained within the existing housing developments of HD*” is false and misleading. In all of Hong Kong’s many HD’s there are **only 3 OVTs**, which are the 3 OVTs illustrated in Figures 5F, 5G and 5H. Three OVTs in all of HK’s HDs cannot be described as “abundant” – a more accurate adjective would be “**rare**”. It is fallacious to claim that the dense development proposed at Fanling would be capable, as claimed in the EIA, of retaining 11 large TPIs adopting Government’s own standards for tree protection, as **Figure 5.2** shows clearly.

For the reasons explained above, the PHD layout in *Figure 6A – Location of Woodland suggested by ACE to be preserved* fails to show the correct number and locations of existing TPI locations and their necessary TPZs derived in accordance with Government’s own tree protection guidelines. See **Figure 5.2** for the correct situation.

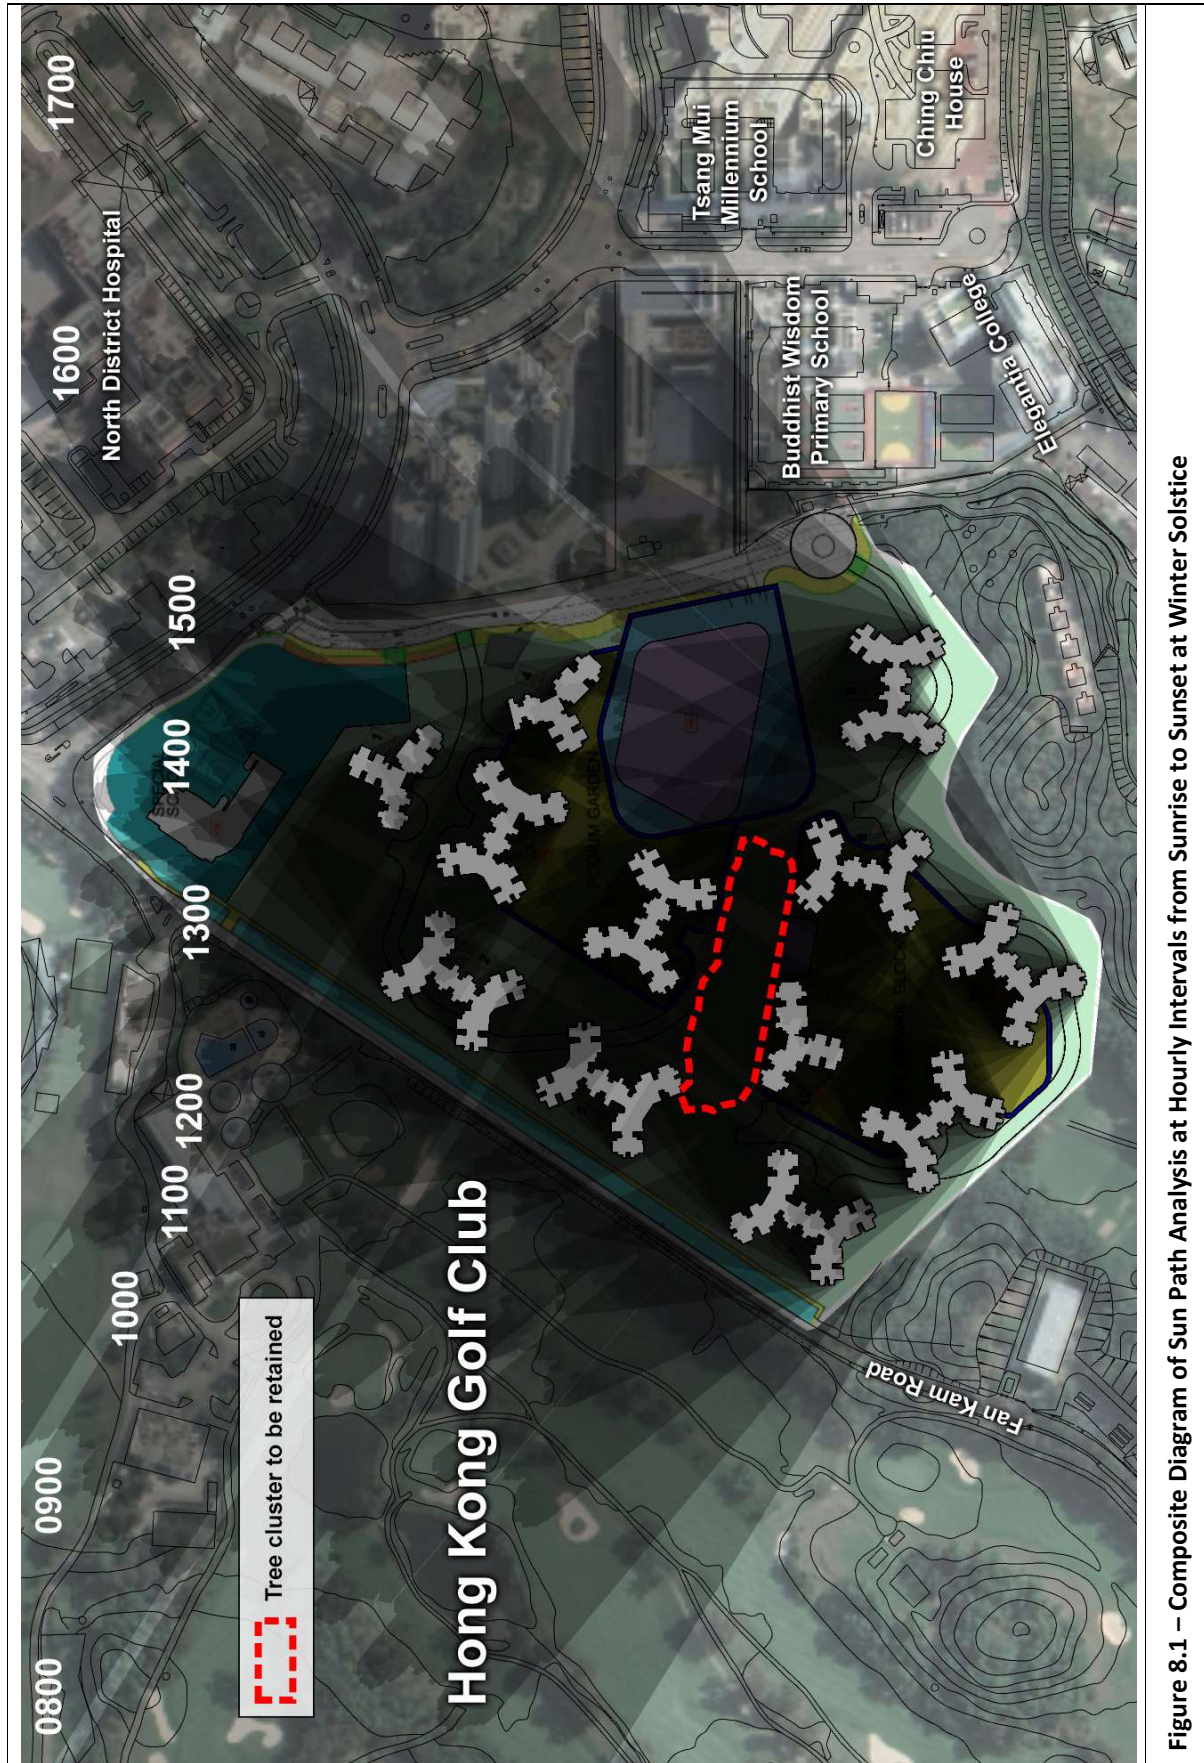
Figure 8.1 – Composite Diagram of Sun Path Analysis at Hourly Intervals from Sunrise to Sunset at Winter Solstice

- b. **Tree Count in paragraph 8.2.2 is wrong.** Due to the poor quality of the EIA Tree Survey, the tree count in the tree cluster is incorrect.
- c. **Sun Path Analysis.** Paragraph 8.2.5 states “*In spring equinox (春分), summer equinox (夏至), autumn equinox (秋分), the retained tree clusters would be able to receive direct sunlight, although in some time of a day, the trees may be shaded by the proposed housing development. The shading is not significant.*” This statement greatly understates the actual shading that will be caused by the buildings, and it is wrong to say the shading is not significant. (Furthermore, there is also no such astronomical event as ‘summer equinox’ – the correct astronomical event is the “summer solstice” - this appears to reveal the consultant’s basic misunderstanding of the information they are trying to present.) Hourly sun-path diagrams for the Winter Solstice and the Spring and Autumn Equinoxes are provided in **Annex 1**. Composite sun-path diagrams are provided in **Figures 8.1 to 8.3**. Sun-path mpegs are also made available. It may be seen from composite diagrams in **Figures 8.1 to 8.3**, the hourly diagrams in **Annex 1** and the mpegs that the tree cluster is surrounded to the north and south by the very tall housing blocks and will receive less than 1 hour per day of sunlight at the Winter Solstice and less than 4 hours per day at the Spring and Autumn Equinoxes. This means the tree cluster will receive less than 4 hours per day of direct sunlight for more than 6 months of the year, which constitutes a very significant and serious shading effect, contrary to the claims in ACE Paper 8/2023. Other TPis which are (unrealistically) being proposed to be retained within the scheme would suffer even more shading than the tree cluster. This is a most significant change from the current situation in which all trees have direct sunlight from soon after sunrise to just before sunset. To say that the shading is not significant is quite incorrect and very misleading.
