## Technical Review of Tree Related Issues in ACE Paper 8/2023

(Rev.2)

This Paper summarizes the findings of a Technical Review of Sections 5, 6 and 8 of ACE Paper 8/2023: Reporting of the Additional Information prepared for the EIA Report on “Technical Study on Partial Development of Fanling Golf Course – Feasibility Study”. Reference is also made where appropriate to the original Environmental Impact Assessment (EIA) Report that was uploaded for public viewing in June 2022.

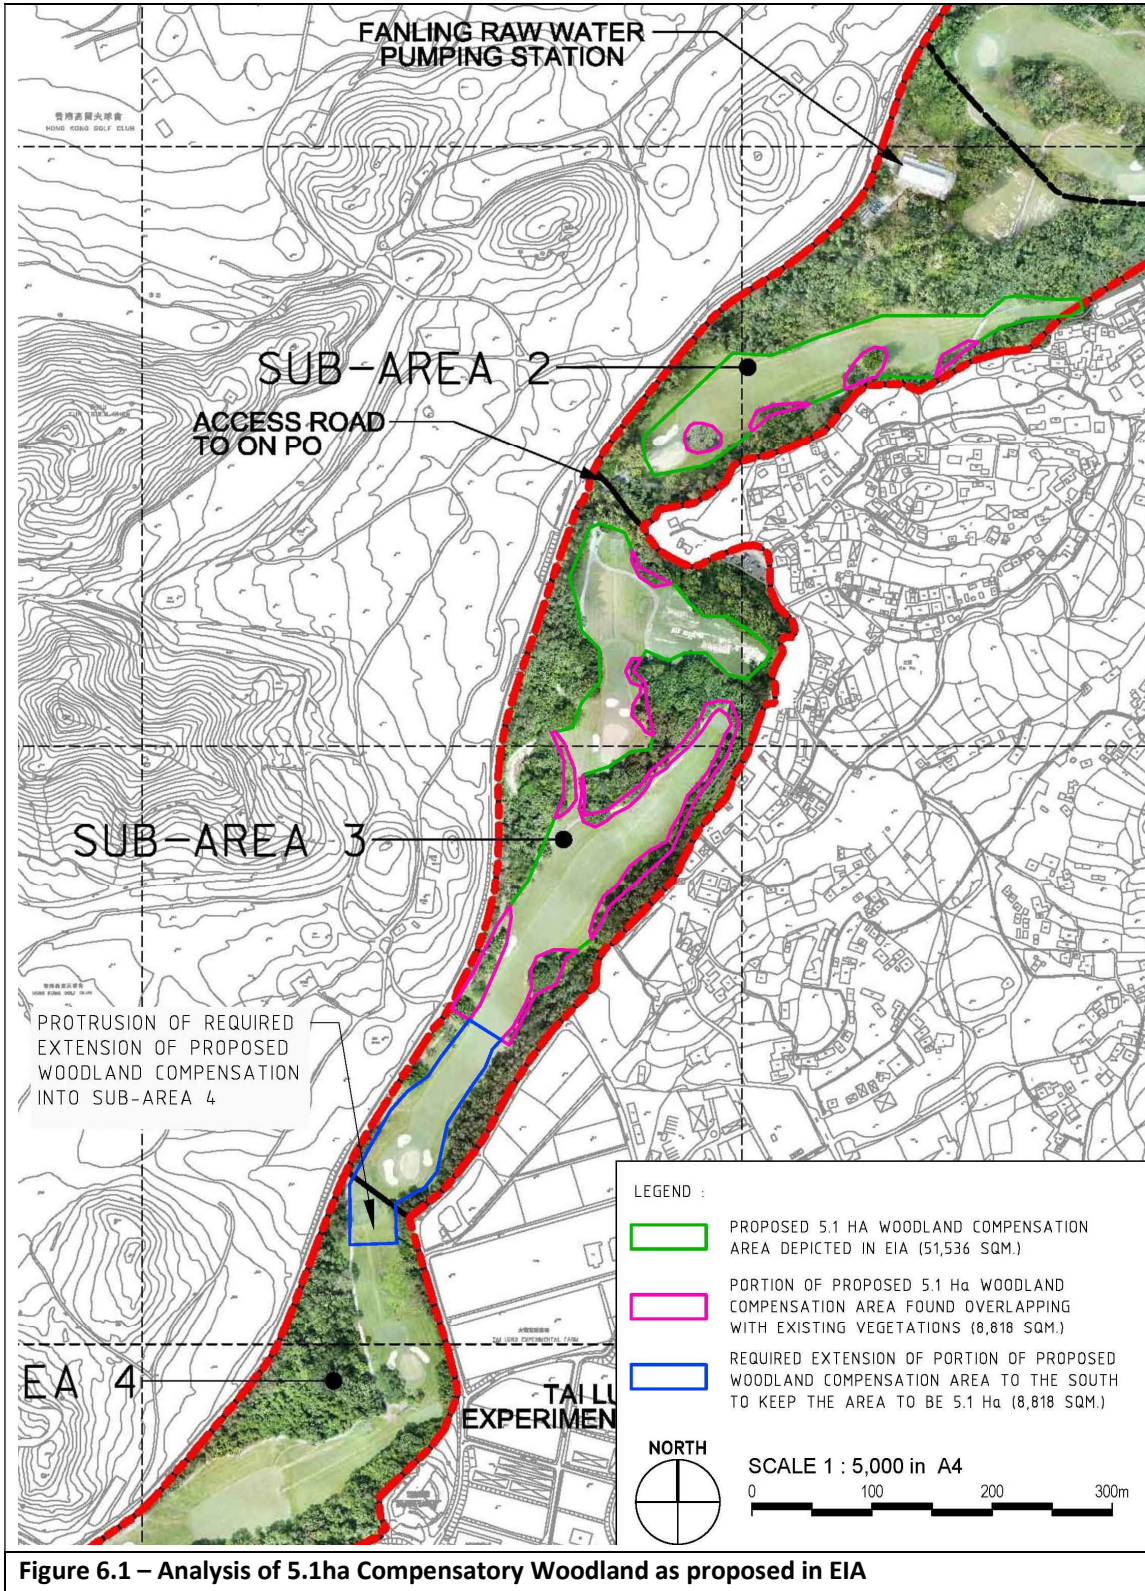
As mentioned above, the proposed 5.1ha woodland compensation is inconsistent with the tree compensation proposal described in ACE Paper 8/2023 section 5 and illustrated in Figure 5B. Furthermore, the 5.1ha is inaccurately plotted in the original EIA - some of the compensation woodland planting is shown in locations where there is existing woodland to be retained. This means that to create 5.1ha of woodland it would be necessary to extend the planting further south into Sub-Area 4, thus greatly endangering the survival of the Chinese Swamp Cypress located there. See **Figure 6.1** which shows the actual area required to provide 5.1ha of woodland planting.

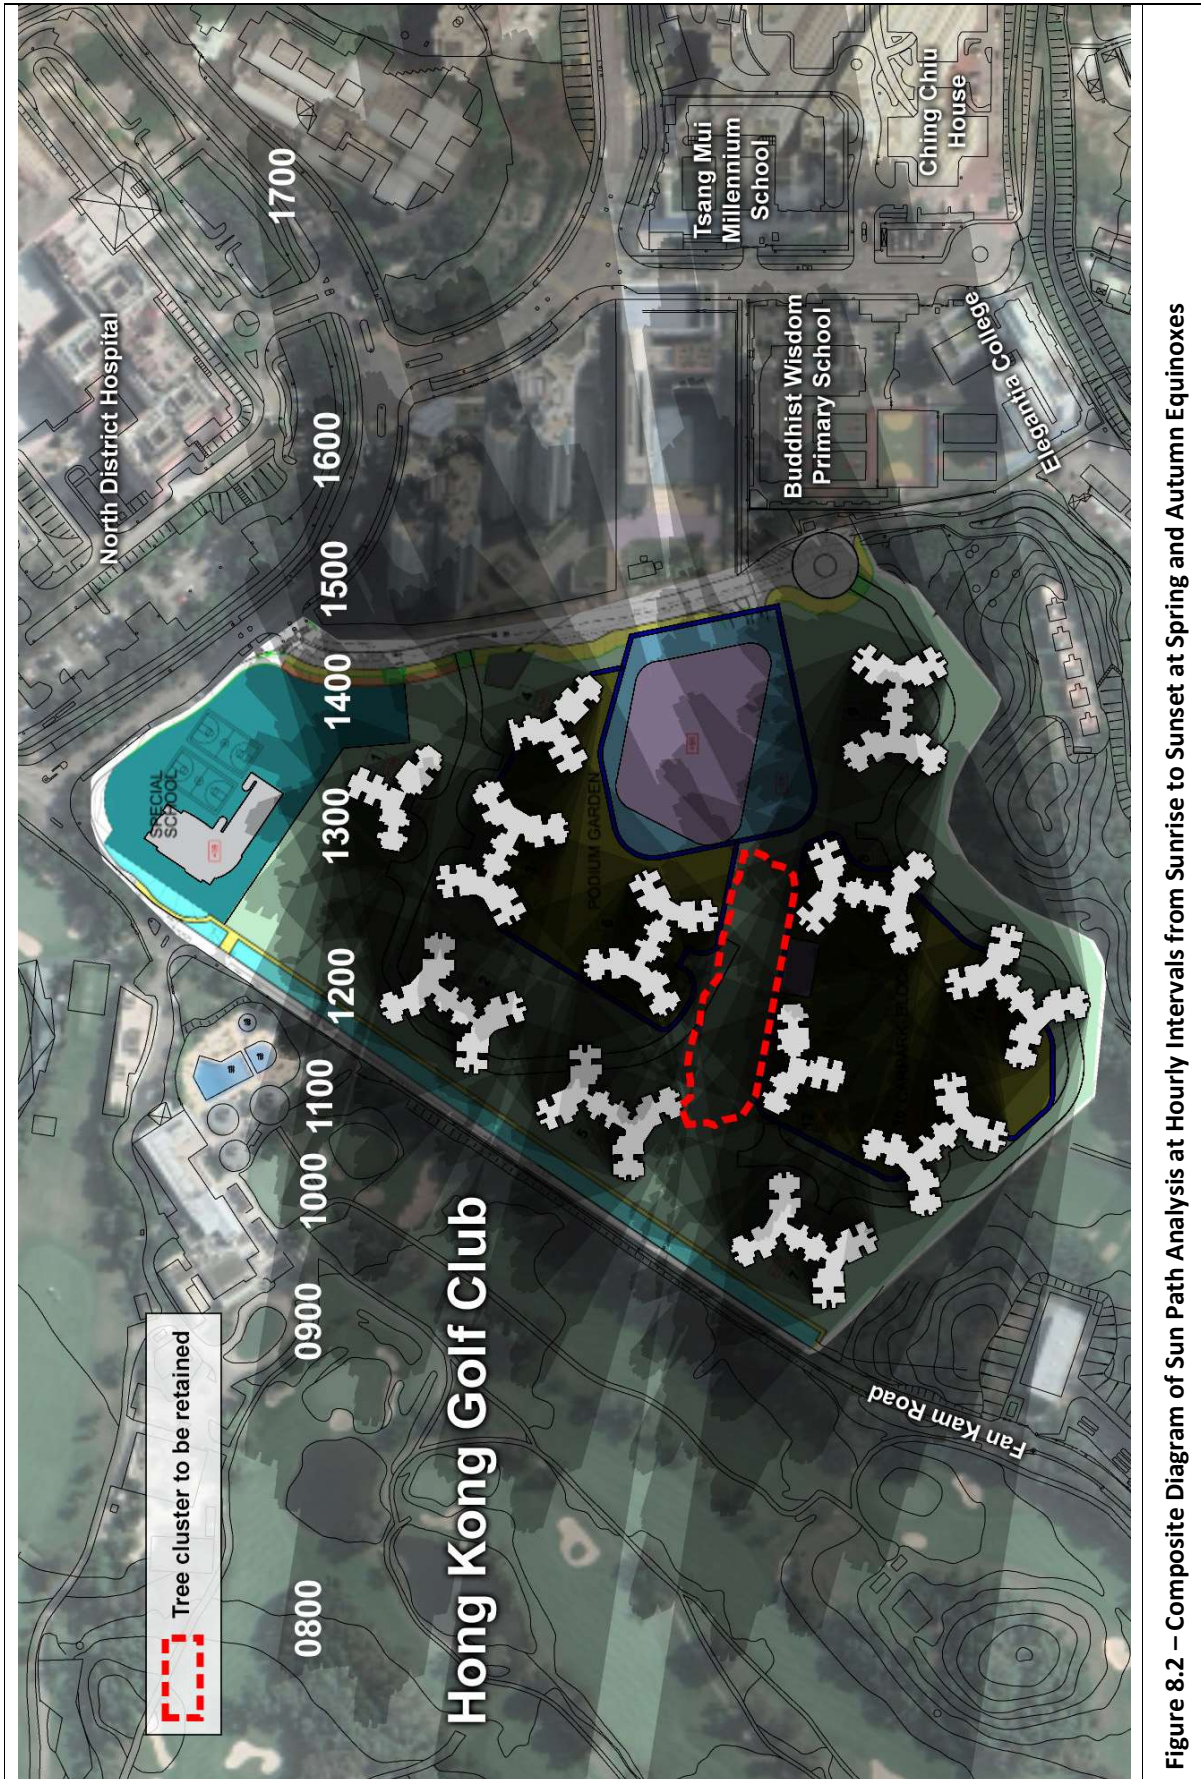
- b. **Tree Count in paragraph 8.2.2 is wrong.** Due to the poor quality of the EIA Tree Survey, the tree count in the tree cluster is incorrect.
- c. **Sun Path Analysis.** Paragraph 8.2.5 states “*In spring equinox (春分), summer equinox (夏至), autumn equinox (秋分), the retained tree clusters would be able to receive direct sunlight, although in some time of a day, the trees may be shaded by the proposed housing development. The shading is not significant.*” This statement greatly understates the actual shading that will be caused by the buildings, and it is wrong to say the shading is not significant. (Furthermore, there is also no such astronomical event as ‘summer equinox’ – the correct astronomical event is the “summer solstice” - this appears to reveal the consultant’s basic misunderstanding of the information they are trying to present.) Hourly sun-path diagrams for the Winter Solstice and the Spring and Autumn Equinoxes are provided in **Annex 1**. Composite sun-path diagrams are provided in **Figures 8.1 to 8.3**. Sun-path mpegs are also made available. It may be seen from composite diagrams in **Figures 8.1 to 8.3**, the hourly diagrams in **Annex 1** and the mpegs that the tree cluster is surrounded to the north and south by the very tall housing blocks and will receive less than 1 hour per day of sunlight at the Winter Solstice and less than 4 hours per day at the Spring and Autumn Equinoxes. This means the tree cluster will receive less than 4 hours per day of direct sunlight for more than 6 months of the year, which constitutes a very significant and serious shading effect, contrary to the claims in ACE Paper 8/2023. Other TPis which are (unrealistically) being proposed to be retained within the scheme would suffer even more shading than the tree cluster. This is a most significant change from the current situation in which all trees have direct sunlight from soon after sunrise to just before sunset. To say that the shading is not significant is quite incorrect and very misleading.

- d. **Dr Kuo’s advice is based on wrong information.** We would agree with Dr Kuo’s advice that “*mature trees being periodically shaded for two months in winter, while receiving direct sunlight in other time of the year, would not be significantly impacted in health.*” **But, as explained above and as illustrated in Figures 8.1 to 8.3, the sun-path diagrams in Annex 1 and the mpegs, the degree of shading described in the above quote is not the actual situation that will result from the proposed PHD.** Dr Kuo therefore appears to have been misled.
